Subject: **Milwaukee County Fleet Garage – Condition Assessment Report
10320 W. Watertown Plank Road, Milwaukee, Wisconsin
ZS Project No.: 7523**

The following is a report of the ZS assessment of the main roof systems at the Milwaukee County Fleet Management maintenance and vehicle storage garage in Milwaukee, Wisconsin.

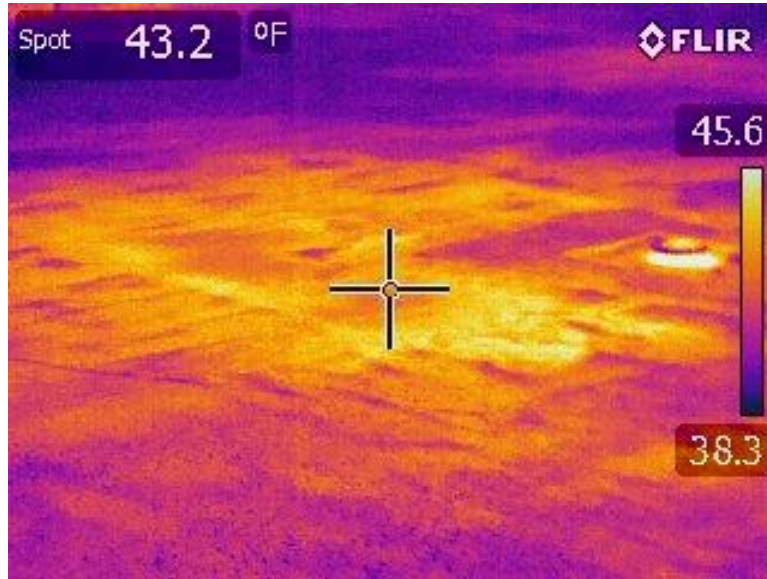
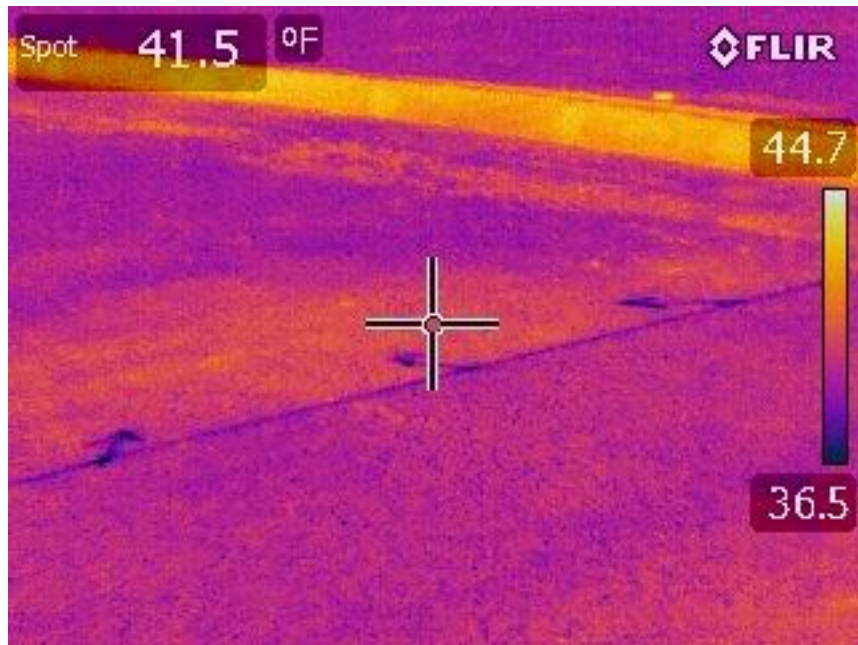
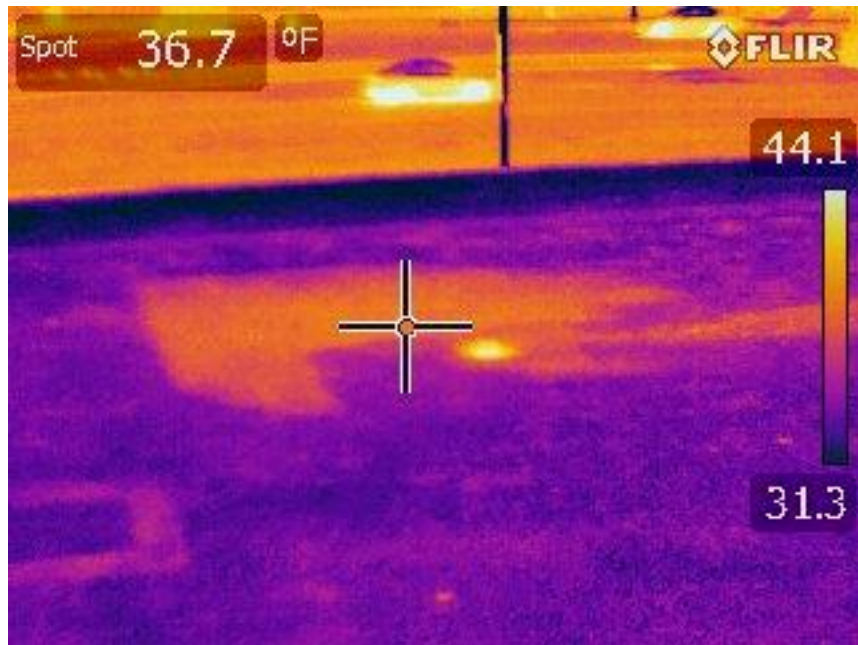
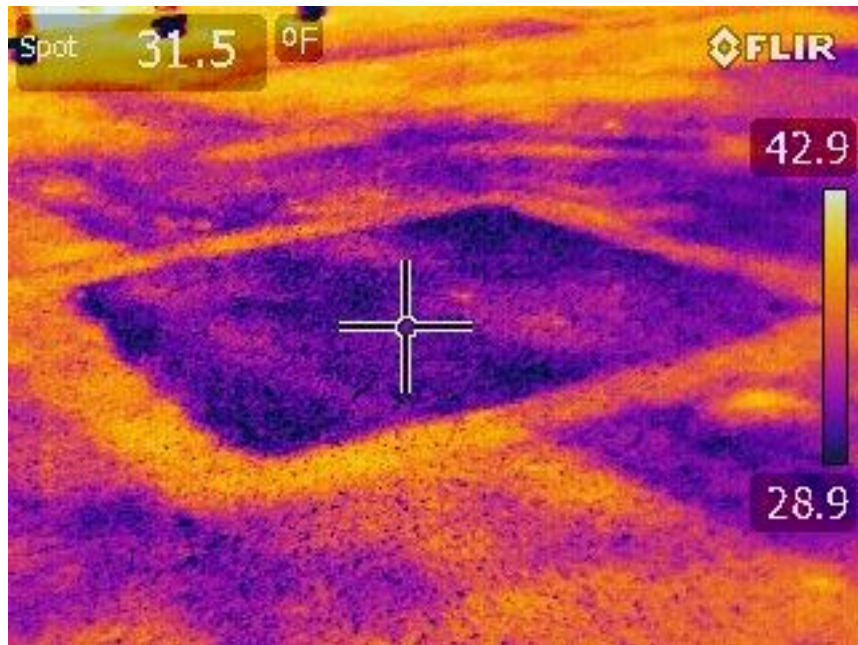
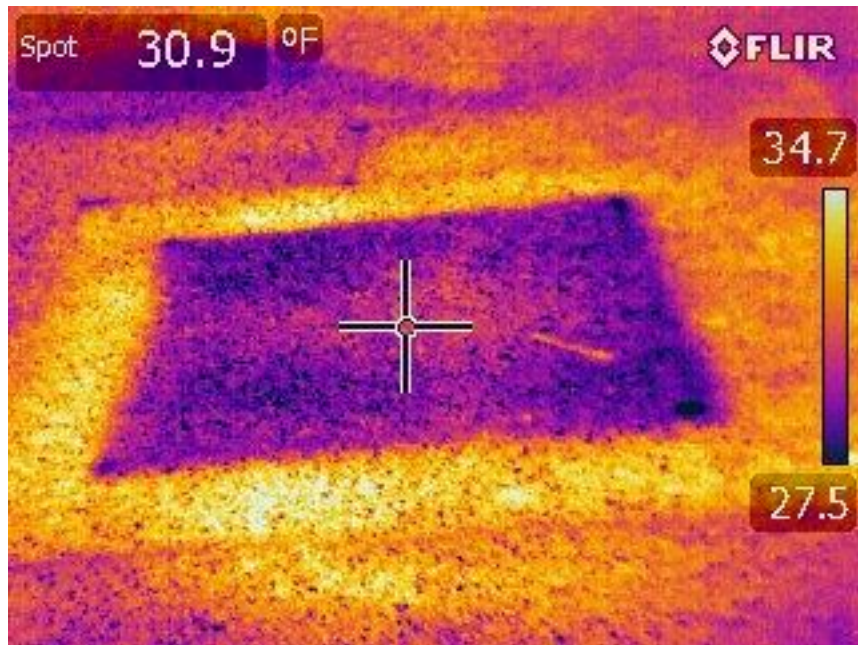
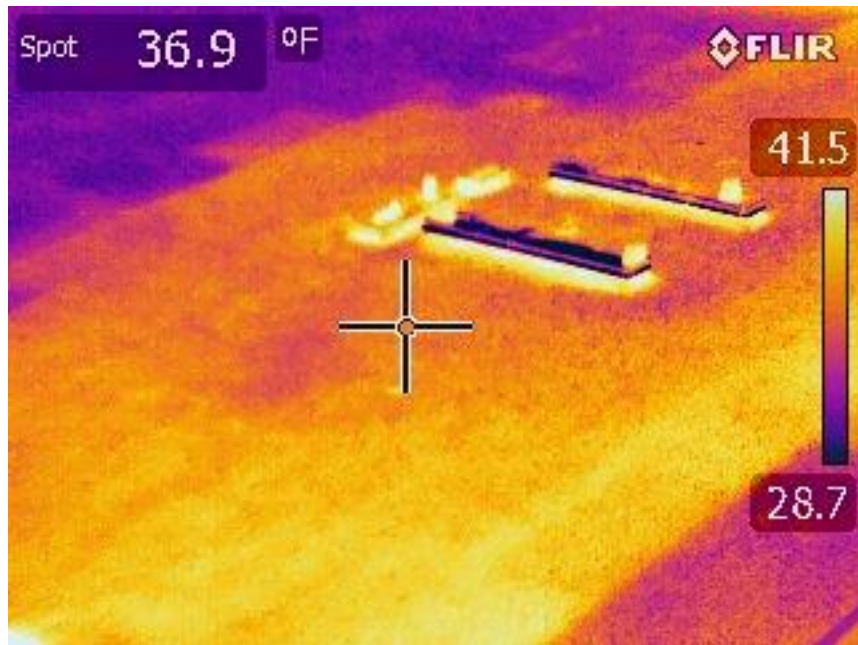
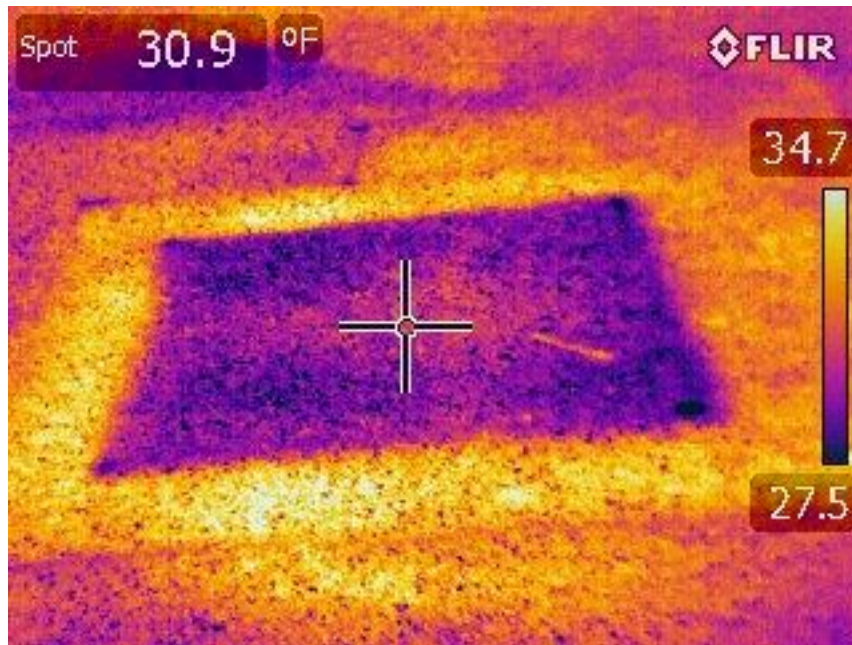
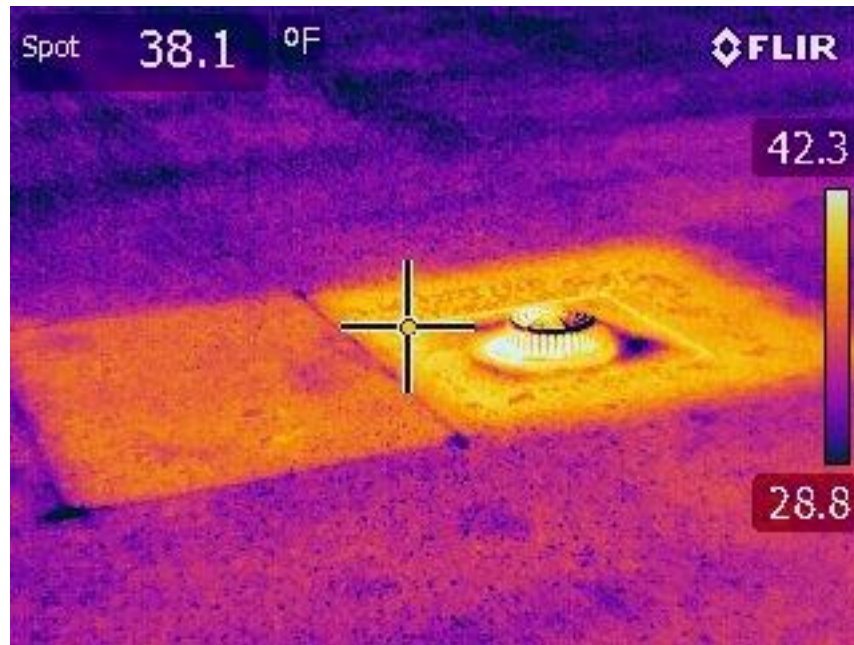
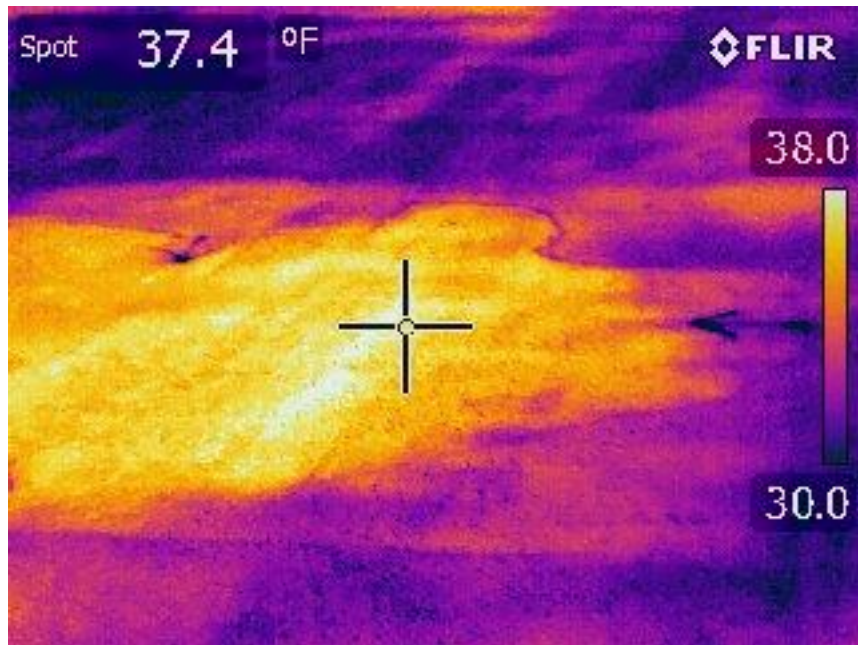
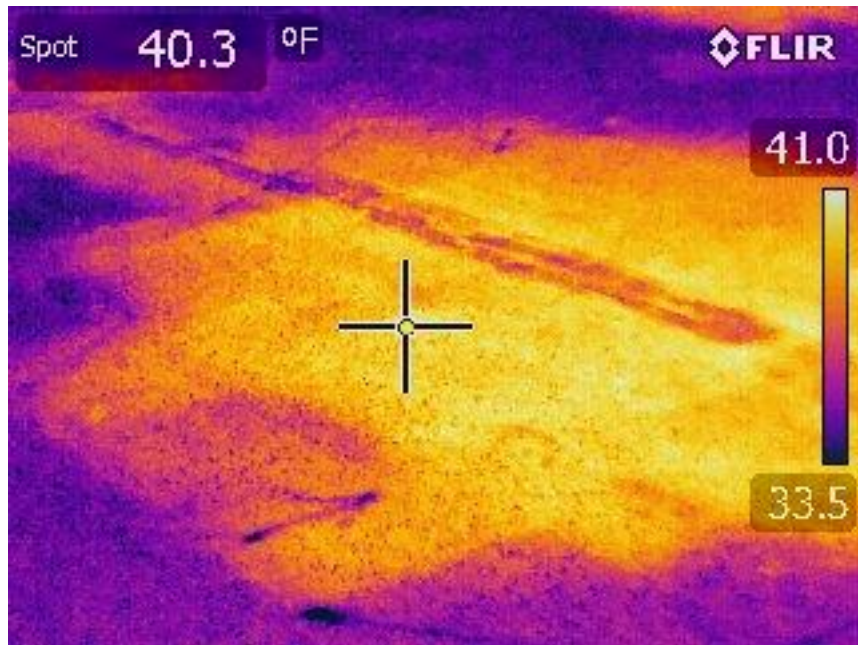
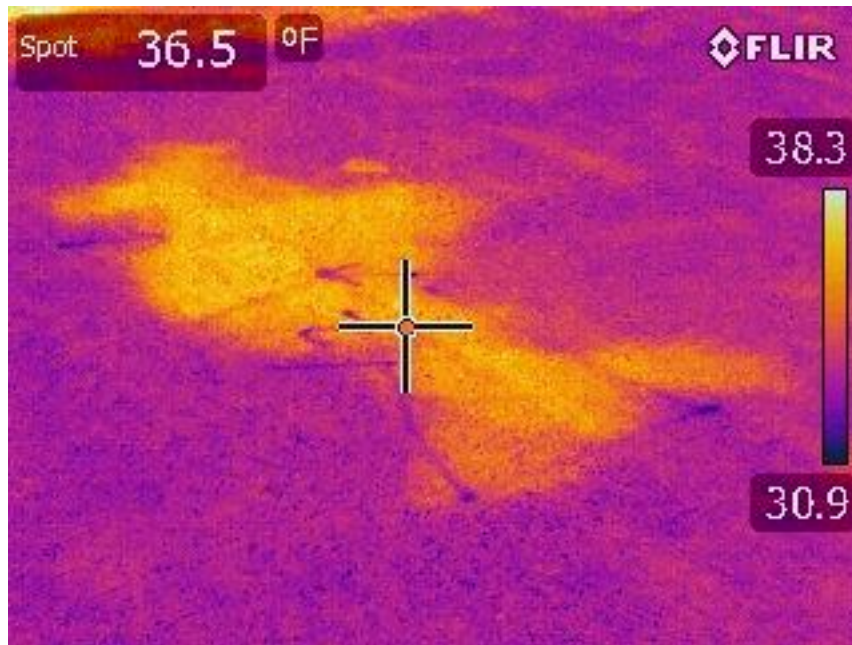
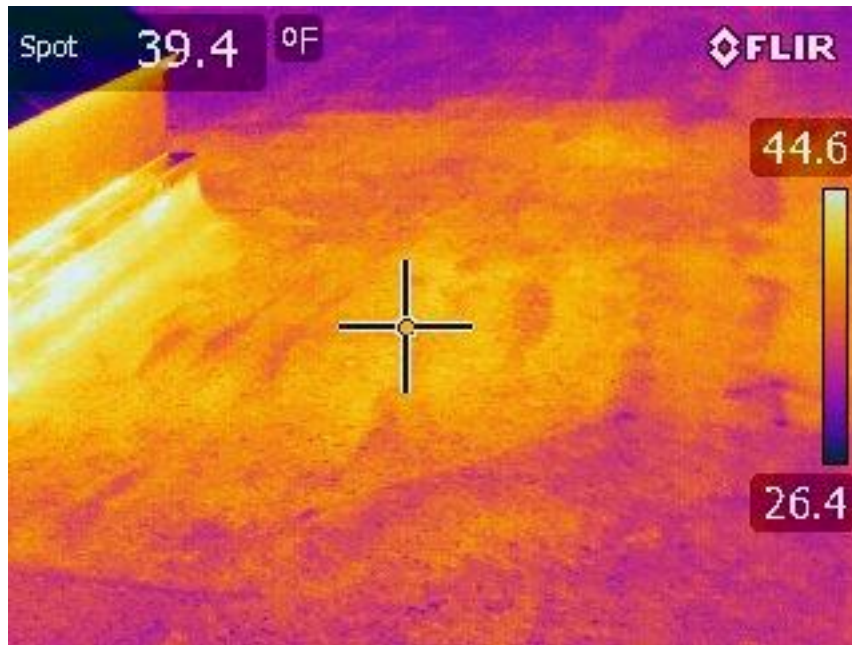
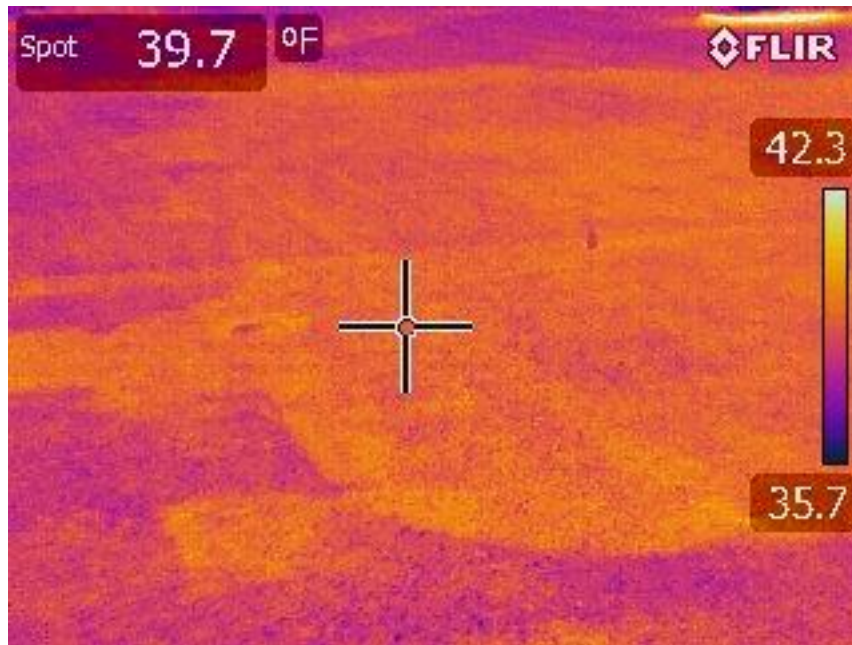
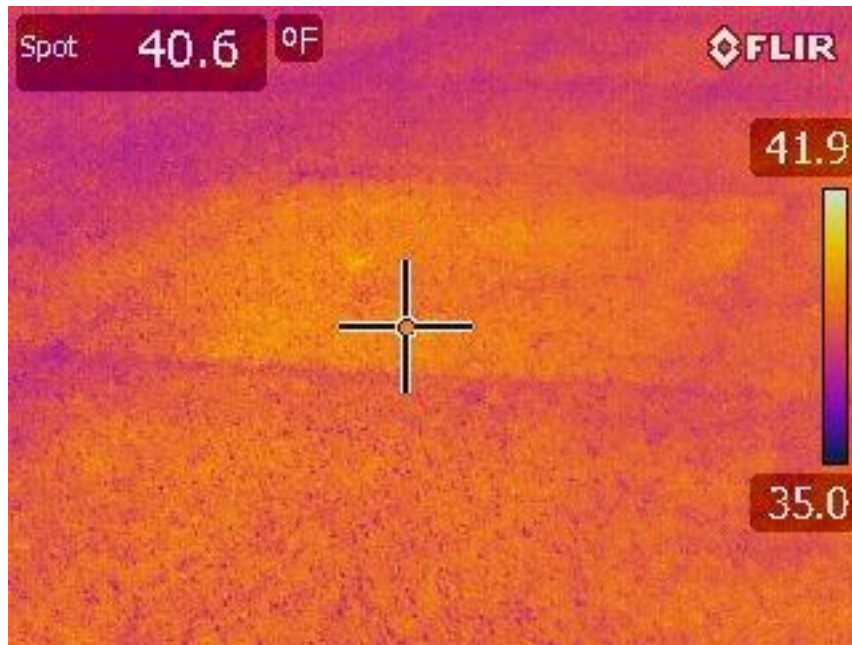
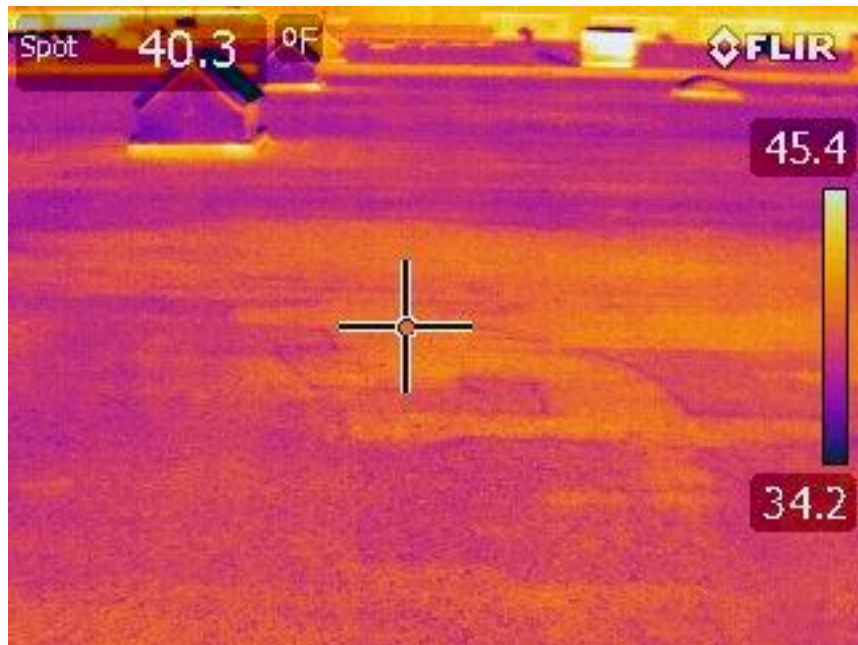
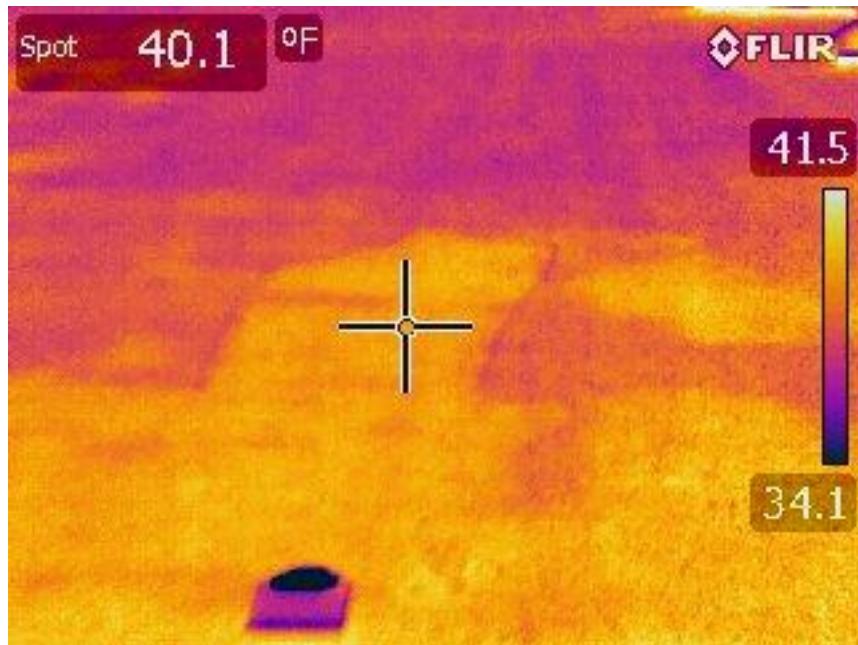
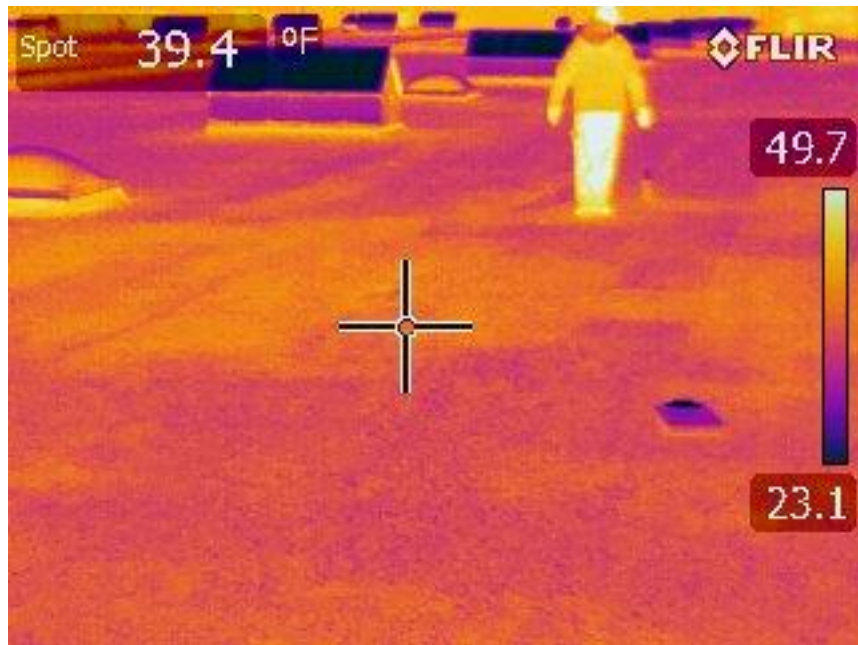
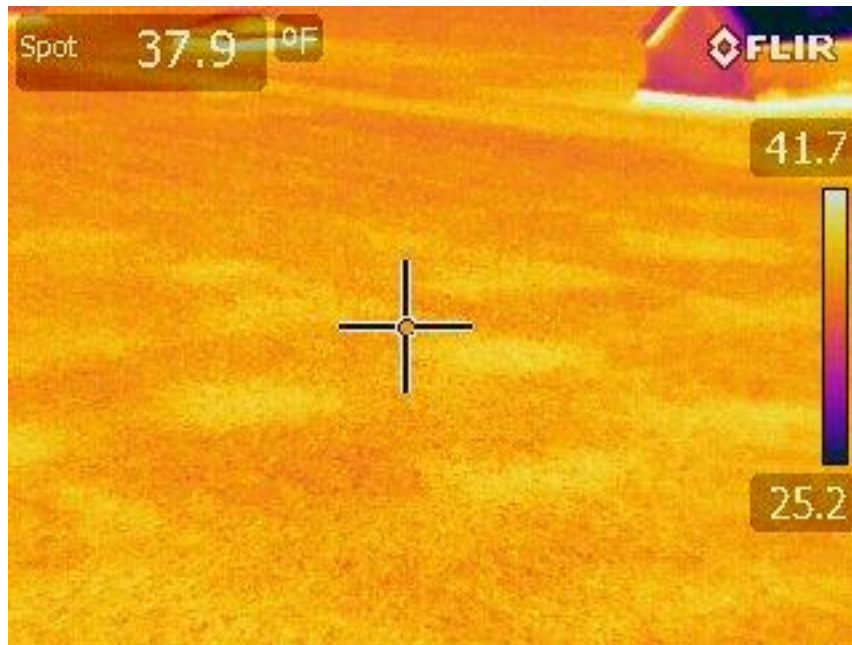
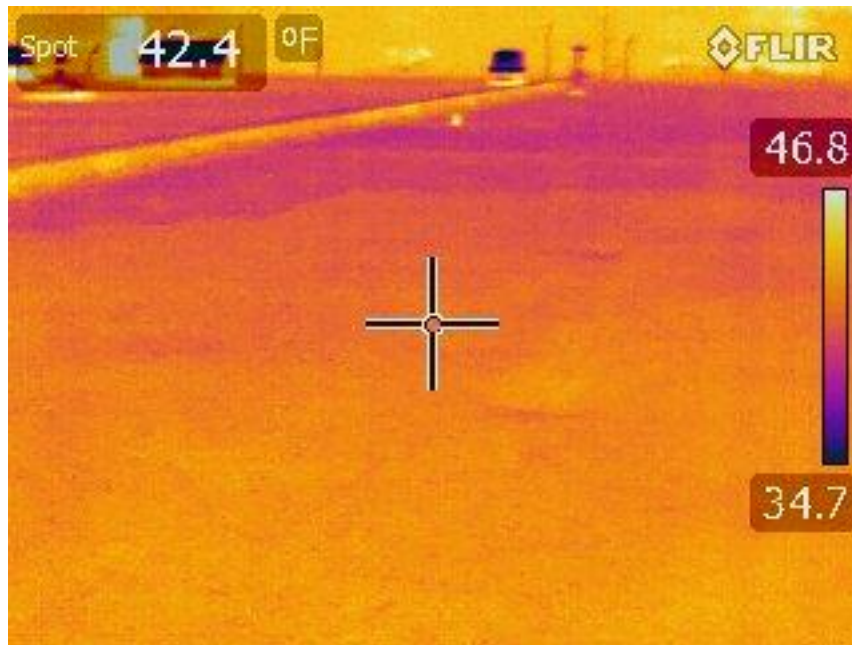
- Thermal anomalies were observed at multiple locations in the field of the roof. Large areas of thermal anomalies were observed in various locations under various conditions, often but not always corresponding to areas of puddling water. See Appendix B for locations and photos (Figures 19-55) for the thermal anomalies.

Figure 19: IR Image with thermal anomaly.
